## 4.4 KENNEDY CREEK CHECK AND WASTEWAY

#### 4.4.2 Existing Conditions and Deficiencies

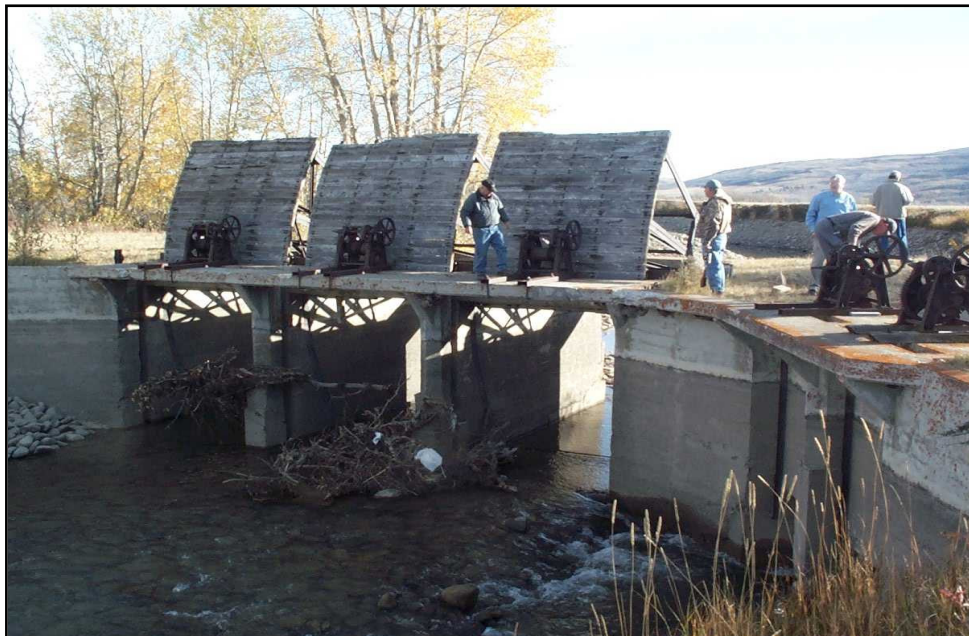
**Figure 4.4.1** Upstream view of Kennedy Creek check structure. Wasteway is located at right side of photo (10/13/04).

The concrete structure overall is in fair to poor condition. The channel divider walls between the gates and the abutment wall have many areas of deteriorated concrete. Past concrete repairs are apparent and generally appear to be holding.

The wooden gate faces are badly deteriorated. Each gate is equipped with a mechanical hoist and cable system to raise and lower the gate. The cables have worn grooves in the wood face of the gates. The gates are chained so that they cannot close without removing the chain. BOR studies indicate that the gates are inoperable. Their deteriorated condition makes it probable they would perform poorly if they were operable. Hand-laid rip rap upstream and downstream of the structure appears in good condition.

The Kennedy Creek check structure concrete has been repaired in the past and could be serviceable for a while. The gates, however, are not usable. Since the check structure protects the downstream portion of the canal from flooding, the existing structure poses risk to this reach. A new structure with power actuated gates and a radio telemetry and supervisory control and data acquisition (SCADA) system is recommended. An operating wasteway is an integral part of the check and control system.

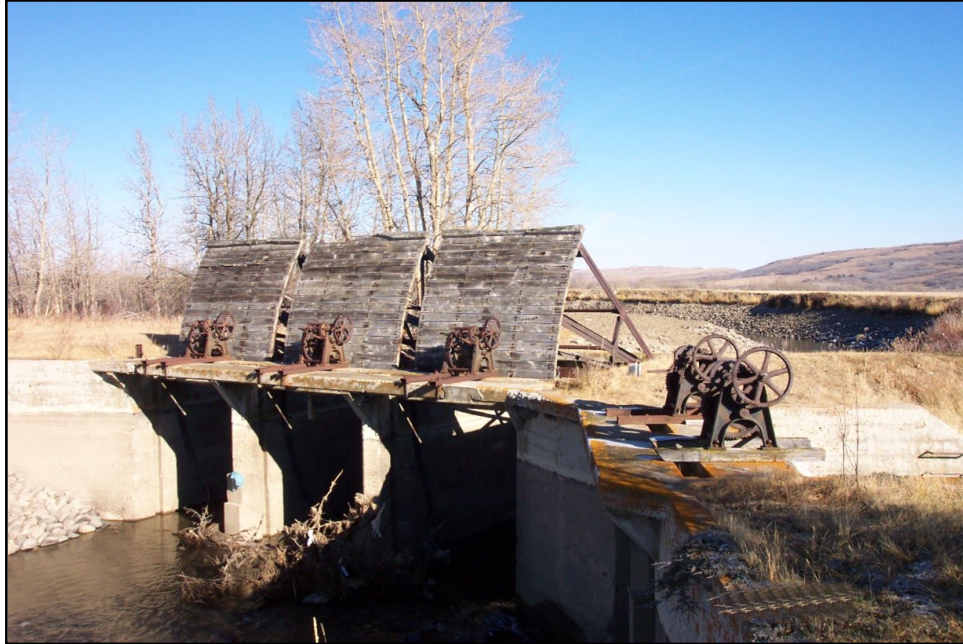
The concrete on the wasteway portion of the structure is in a much more deteriorated condition. There is significant spalling and reinforcing steel exposed in each of the raceways above the low water line. The downstream walls and center wall are also in poor condition. The top slab is extremely deteriorated and can no longer support the reaction thrust produced by the gate operators. Steel beams have been placed beneath the operator for the only operable gate to support the gate reaction load (Figure 4.4.2).

**Figure 4.4.2** Upstream view of Kennedy Creek check structure (left) and wasteway (right). Note modifications to wasteway operator slab to maintain operation (11/11/04).

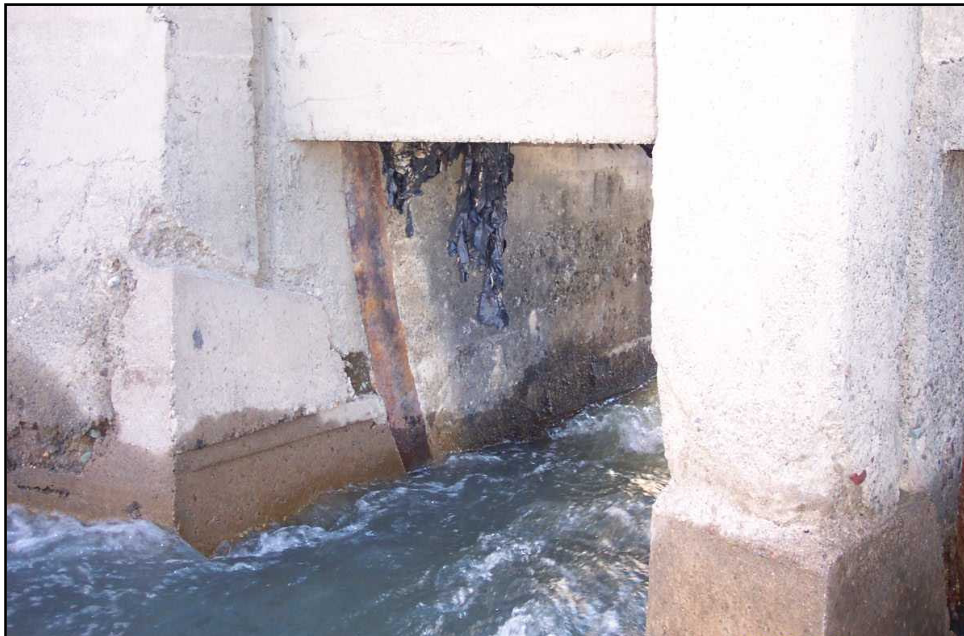
**Figure 4.4.3** Upstream view of wasteway. Note condition of concrete. Wasteway is open during off-season to drain inflows and seepage (11/11/04).

The other gate has wood wedges driven around the perimeter in an attempt to seal it and doesn't appear operable. The faces of both gates have been covered with plastic since the wood is deteriorating.

The Kennedy Creek wasteway structure is contiguous with the check structure. Only one of the two radial gates is operable and the concrete on this structure is badly deteriorated. Repair of this structure is impractical. The structure also lacks basic safety features to protect the operator from falls while operating the gate.

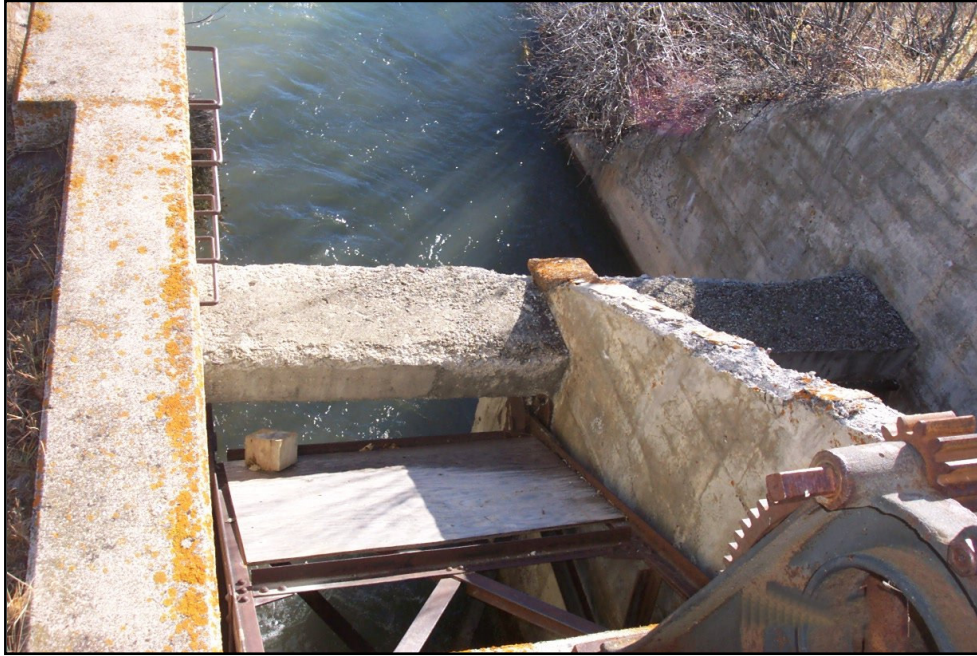
**Figure 4.4.4** Downstream view of wasteway (11/11/04).
